IMPACT OF EXPANDABLE SOIL ON FOUNDATION OF BUILDING STRUCTURES:
THE CASE OF CONDOMINIUM HOUSES IN ADDIS ABABA

M.Sc. Thesis

Dejenie Abere

June, 2017

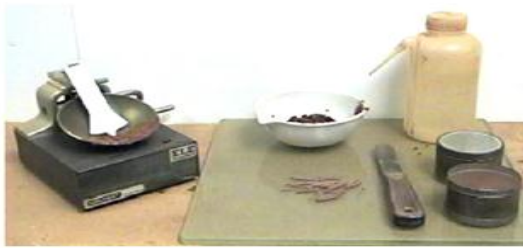
Equipment used for Liquid limit test

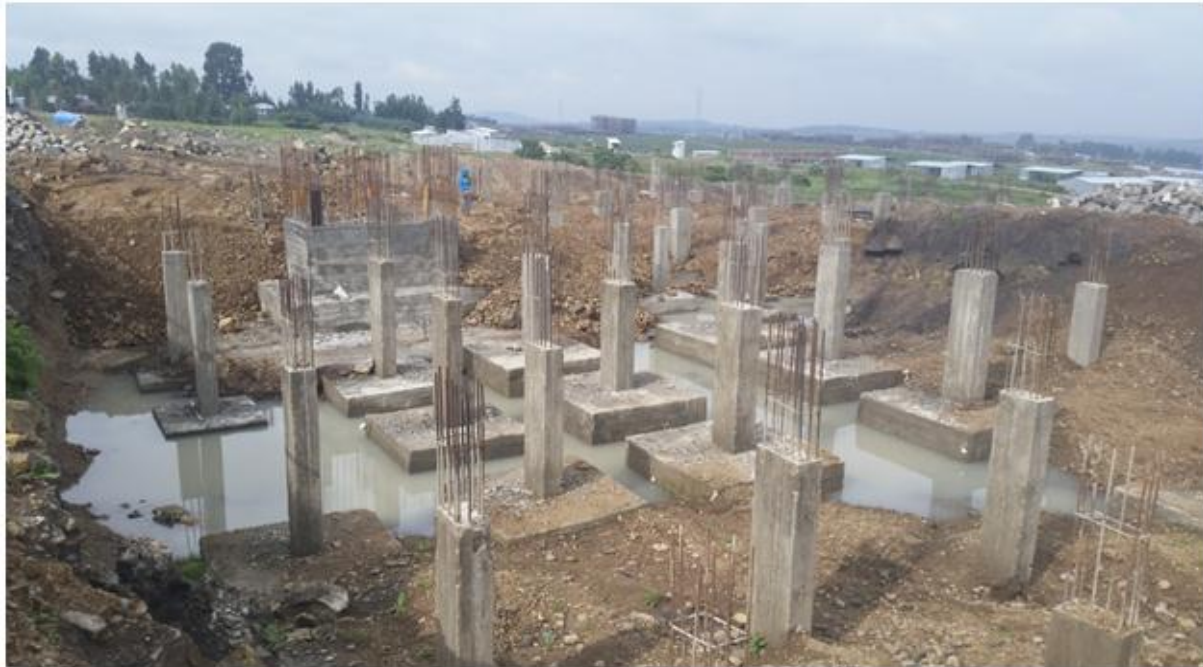
Bole Arabsa 3: Compaction not layer by layer

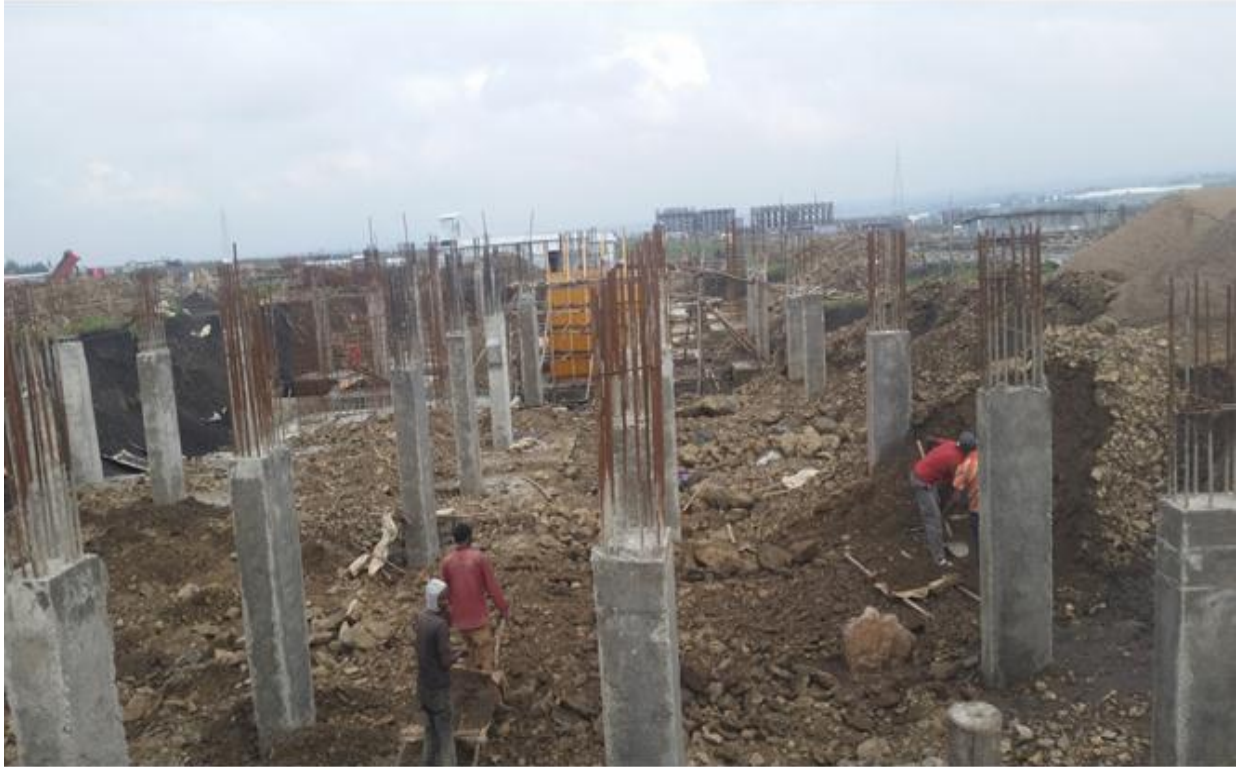
Bole Arabsa 5: Compaction by hand compactor

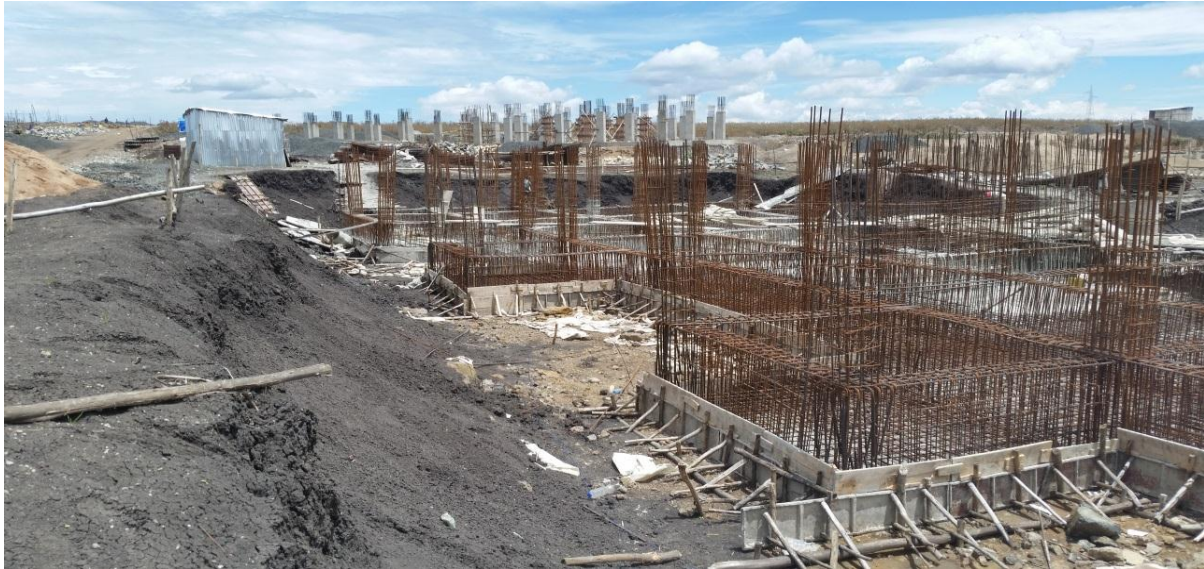
Bole Arabsa 5: Mat Foundation

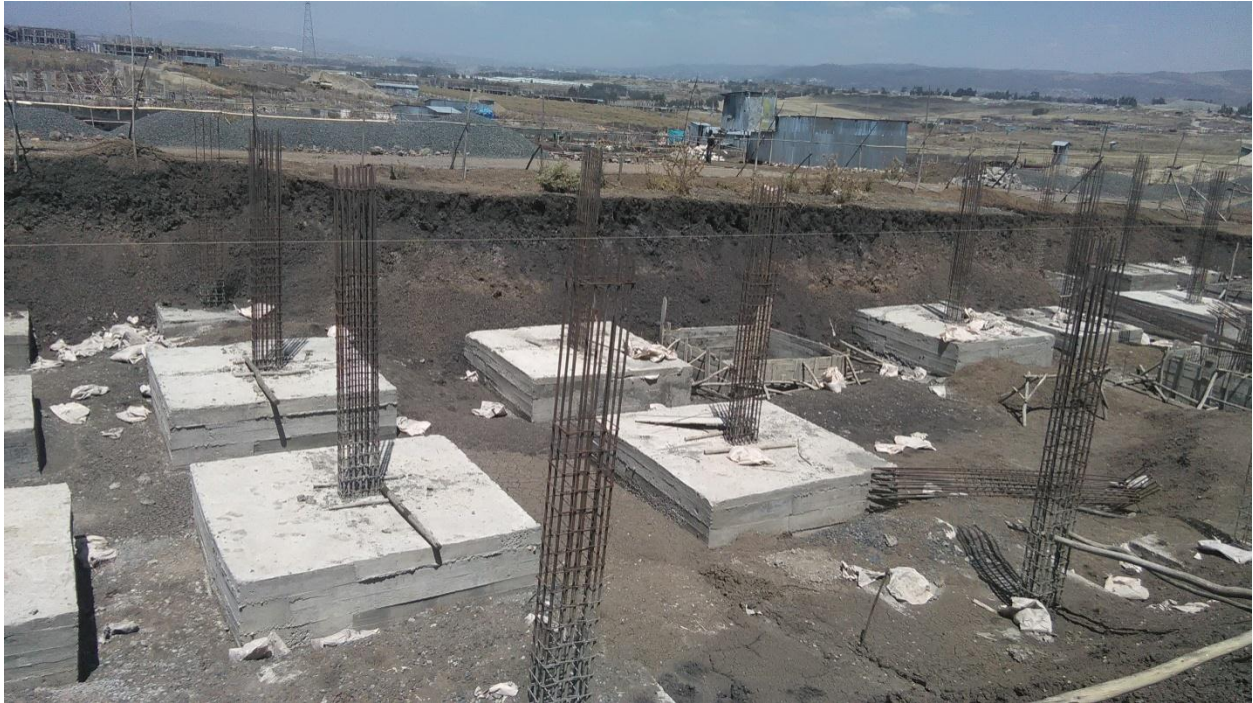
Bole Arabsa 5: Isolated Footing

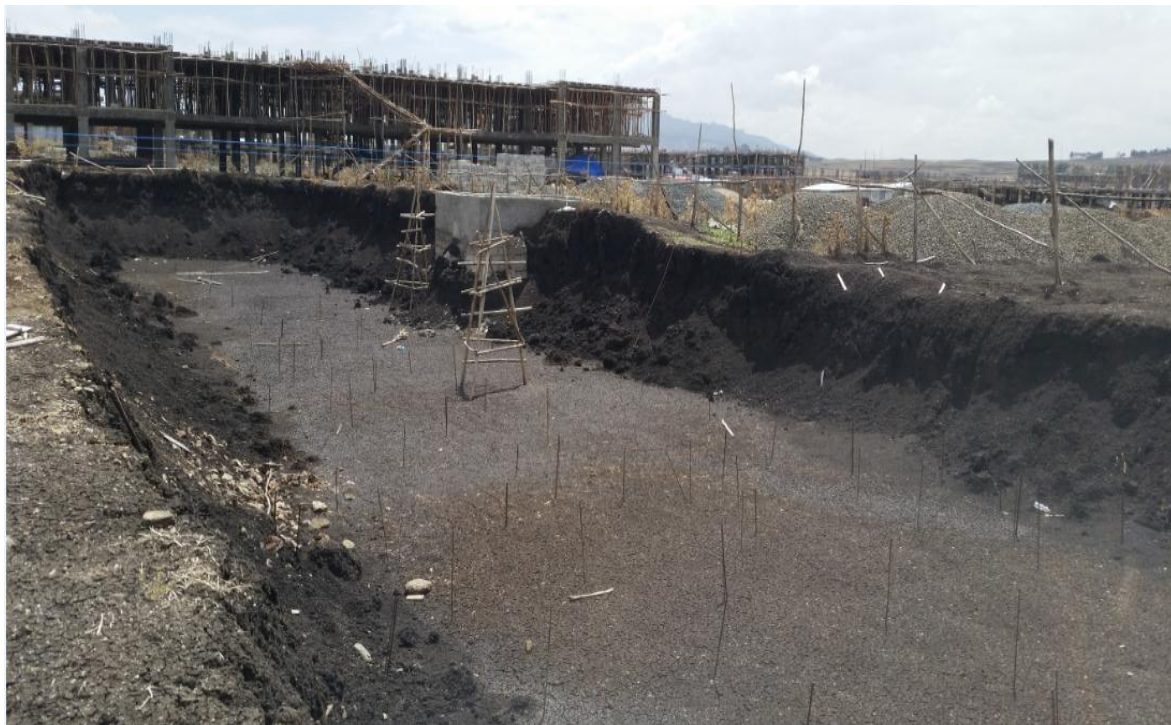
Koyefeché project 16: Selected for isolated footing

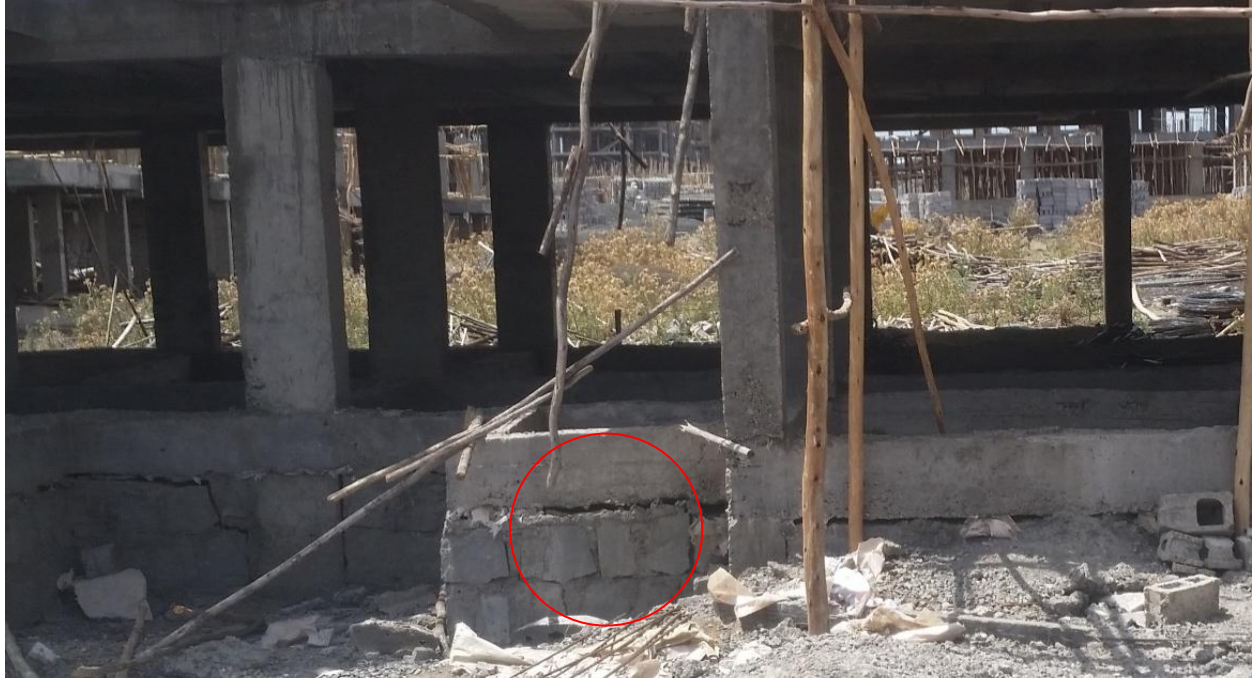
Figure 4.12.Koyefeché Project 12

As shown from figure 4.12, masonry wall expand to the side area and the cause of the problem lies on the workmanships and also this block showed differential settlement problems

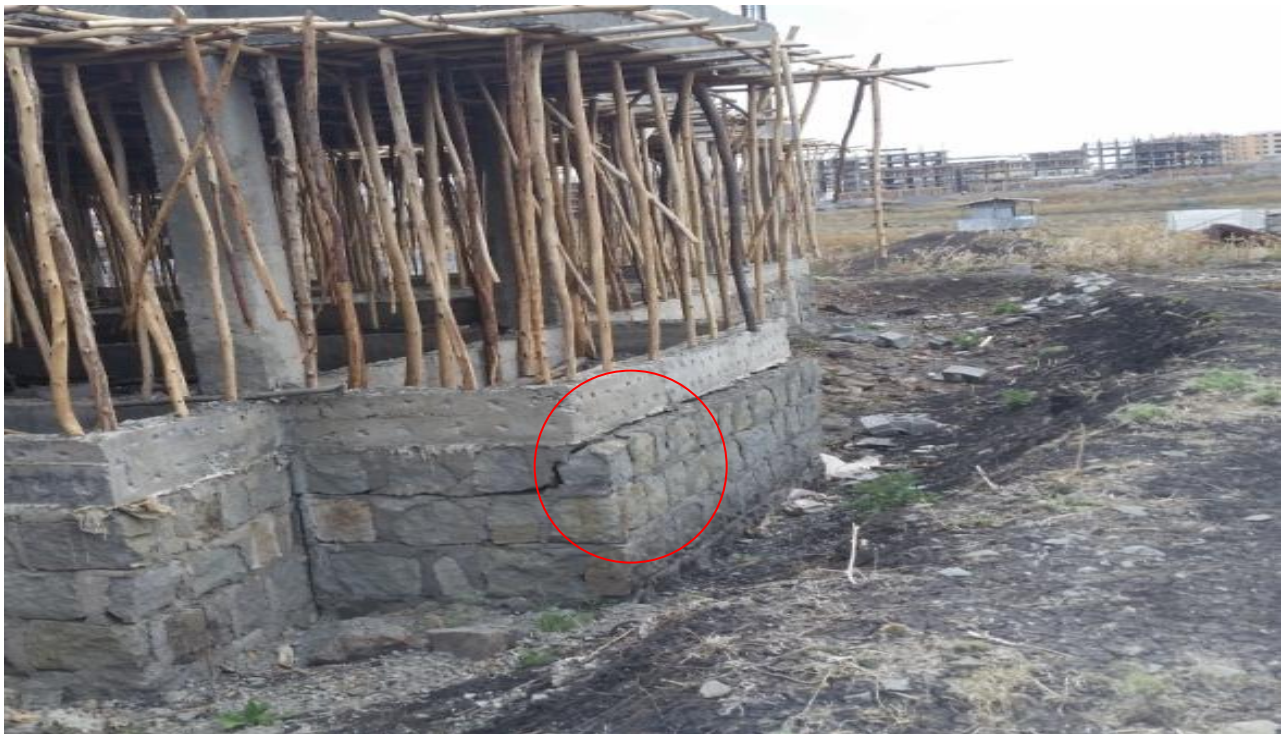
Figure 4.13.Koyefeché Project 12

As shown the above figure 4.13, such problems are enormous in koyefeche project 12 and showed the impact of black cotton soil on the newly foundation. The soils which hold building tend to expand to side area. Internal confining pressure which pushes the masonry walls Because of the above reasons cracks happened in areas where weak joints are available (found) as the witness of field observation. However; in the above figure differential settlements, uniform settlements, tipping settlements are not observed.

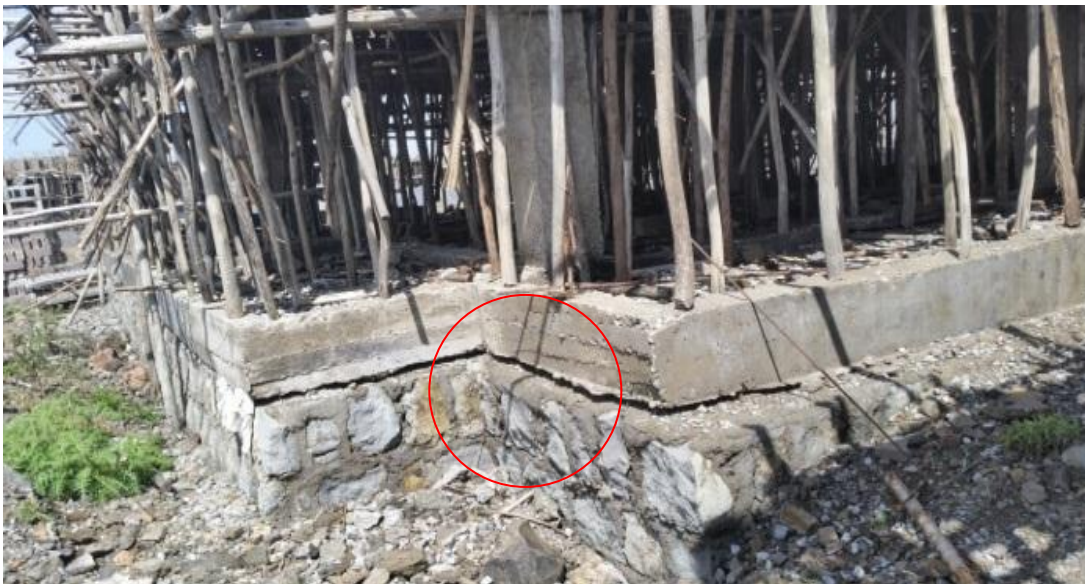
Figure 4.15.Koyefeche Project 17

In figure 4.15Koyefecheproject 17 and figure 4.16Koyefecheproject 16 as the picture displays and it showed differential settlement problem and settlement of masonry wall below the grade beam. In this regard joint parts are exposed to cracking little by little whenever the structural loads are increasing. In addition to the absence of any support from the bottom having crack is inevitable. Then as time goes on load arrangement problem results happen. Apart from the above each column load becomes cause by itself together with the supper structure influence. For example currently we are looking differential settlement even if the load is limited. Therefore grade beam bending movement is clearly visible if the load is imposed (burdened) beyond the limit. In most cases in the study sites footings and slabs are placed directly on expansive soils without proper compaction and backfilling. Different codes set the limiting settlement for the type of the structure and foundations. In the case of EBCS-7, 1995 the allowable settlement 50mm and 75 mm for sandy and clay soil respectively. These settlements depend on a number of parameters basically soil type.

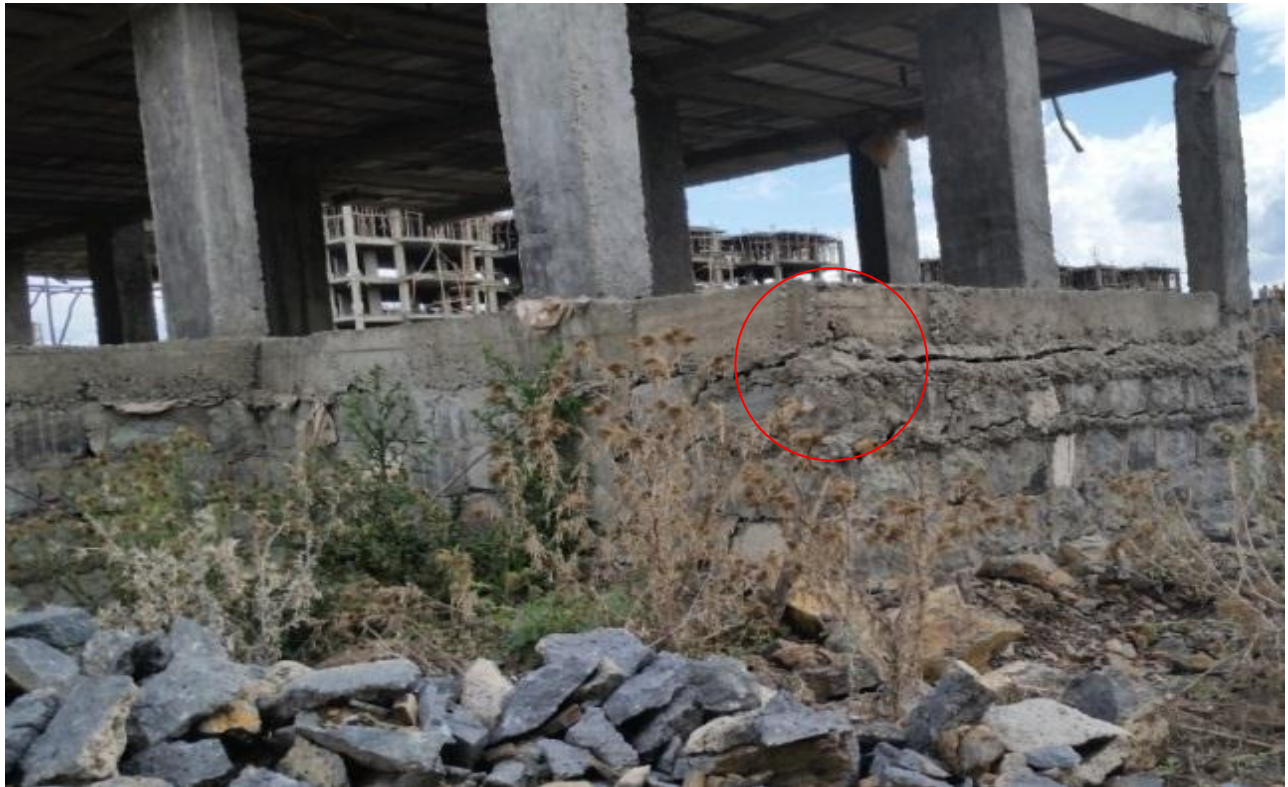
Figure 4.17.Koyefече Project 12

The block as shown in figure 4.17 is found within Koyefeché project 12 on the side of the road margin or pavement of the road. The block is visible to any by passers; the workmanships have tried the best level to cover the cracked part. After crossing this block, you find a lot of cracked buildings with other defects. Apart from the above figure 4.17 shares the same problems with figure 4.13. Nevertheless, the lateral earth pressure detached the masonry wall a parted each other and slide to the external side. Little by little lateral earth pressure commutatively with super structure cause to tending tumbling of the masonry wall entirely. However; In Figure 4.18 koyefecheproject 16, currently the visible problem is differential. It could be possibly caused by failures selecting materials, workmanship, and compaction problem. Areas where differential settlement is existed, flooding is common/available and results equilibrium moisture disturbance. The problem creates moisture disturbance happens on a round the footing and the basement where the masonry wall existed and footed areas finally.

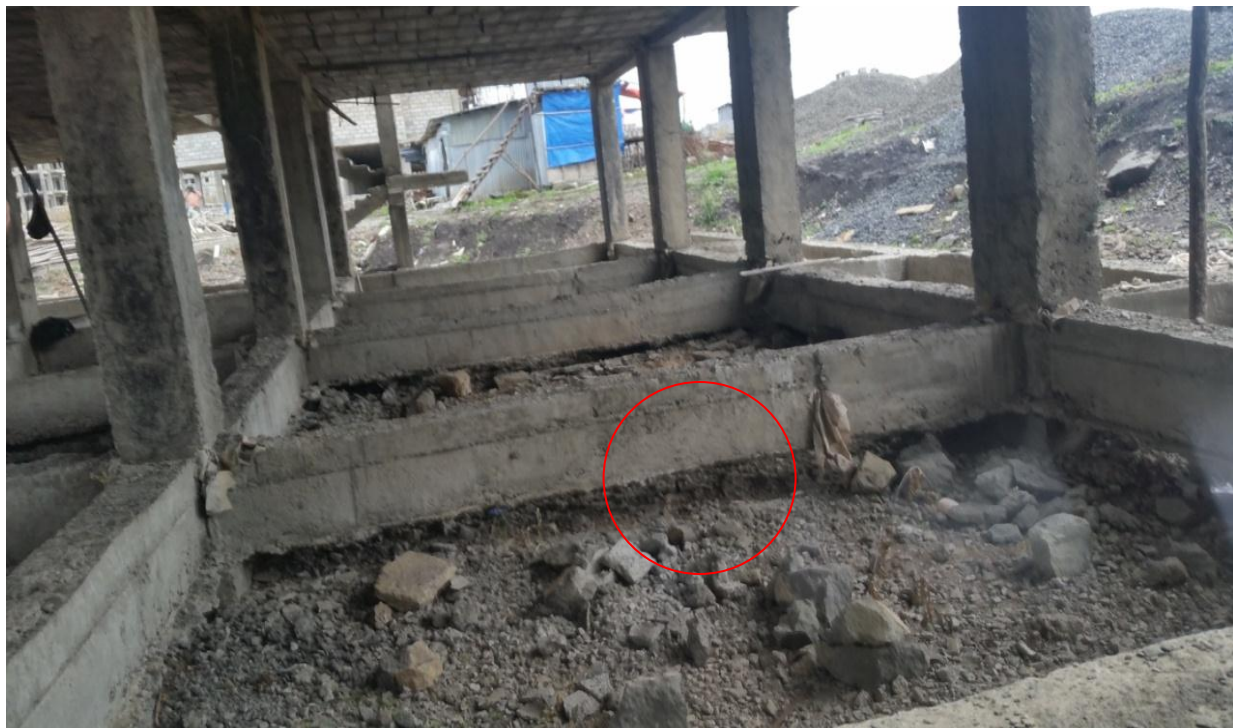
Figure 4.19. Koyefeché Project 17

In this Figure 4.19 and 4.20 the problems observed in this blocks were selecting materials and compaction. If suspended happens on the spot of loading and grade Beam bends, the cause of the problem lies on the workmanships. The grade Beam is designed not in the manner of suspended way rather the design is made on the surface. So we can understand from the above pictures, there is an area which concentrated load presumably that results cracking. This concentrated load makes the grade beam bending and results cracking as well.

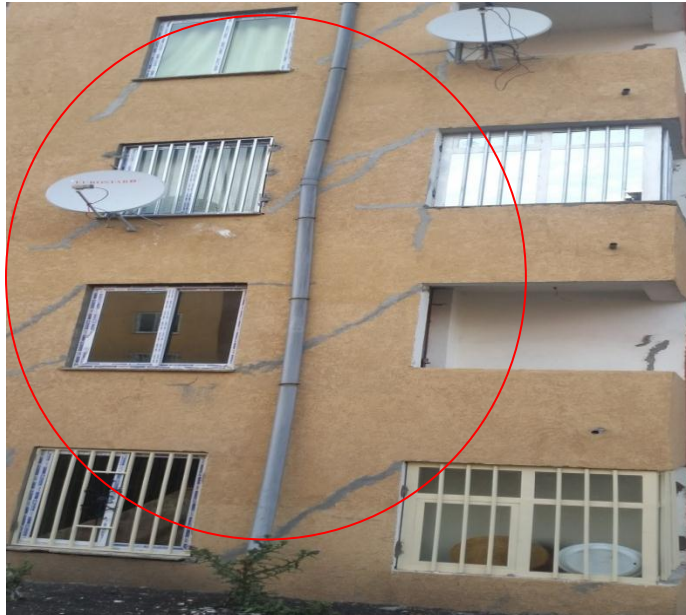
Figure 4.27. Exterior Wall Cracking Due to Differential Settlement Problems (Yeka-Ayat Block 352)

This figure 4.27 shows exterior wall cracking which is covered by cement has been seen by everybody. Pointing or maintenance work by the block inhabitants. Cracks found in condominium, whose pattern are very similar in many cases ranged from Slight cracks to moderate cracks. Most of the cracks originated in the corners and radiated either diagonal pattern of cracking. Some condominium had developed diagonal cracks with a stair-step pattern in blocket walls. They classified as slight to moderate cracks degree of visible damages. Diagonal cracks in the walls, sticking doors and windows, cracks in the floors are the indicators of soil movement. Besides that, cracks may be an indication of instability of the structure. Geotechnical engineers mentioned that slight movement also can cause cracking to large building. Other contributing factors for the damage of condominium houses such as poor design, poor construction in line with poor workmanships, and inadequate observation of construction processes, poor drainage have exacerbated the problem.

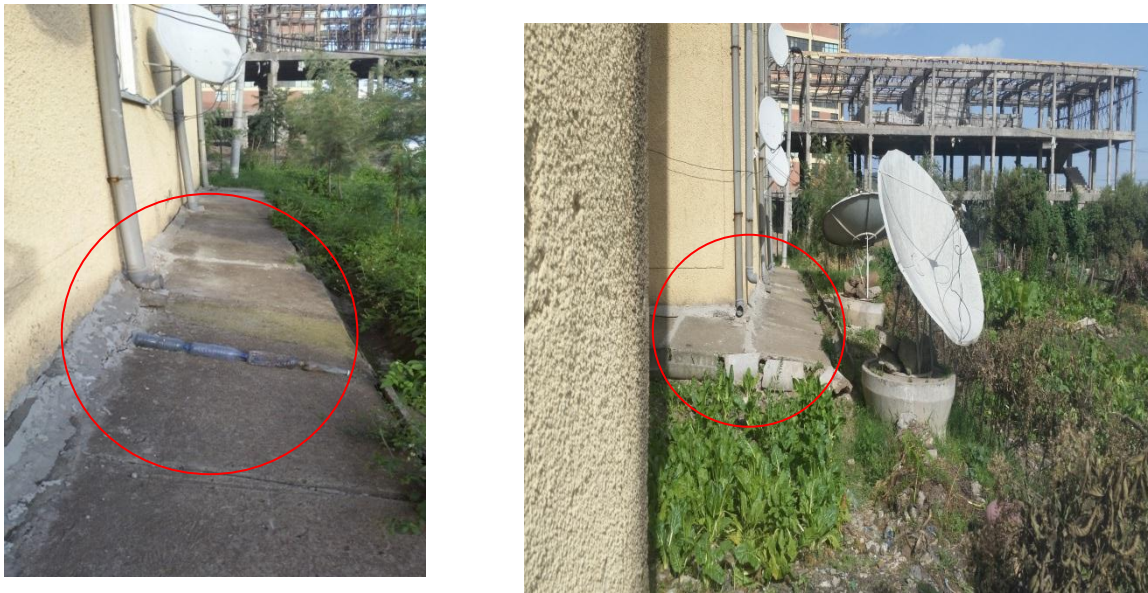
Figure 4.28. Jemo No.1 Condominium Site Block 221 Maintenance of Foundation Walls

The main source of soil moisture changes in the soils is rainfall. Other sources include poor drainage system and poor roof drainage, plumbing leakage and wet spots around the foundation and overwatering.

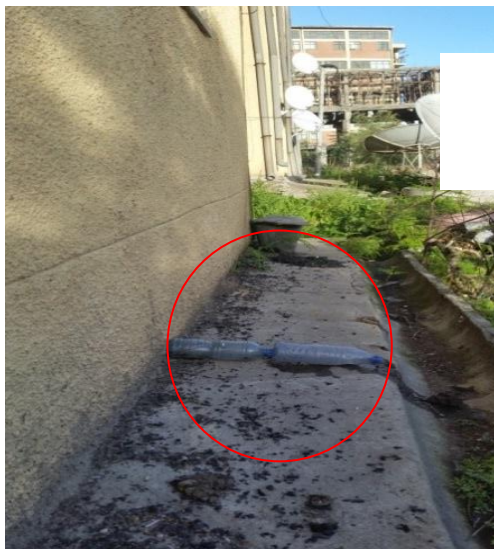
Figure 4.29. JemoNo.1 Condominium Block 220 pavement at the back side

Block 220 has almost 2(two) shoes or two water bottle length pavement whereas block 221 and 219 have a bout 4(four) shoes or four bottle length pavement each from the foundation walls. This block 220 is showed tipping settlement and residents who fully left the entire block. Water which flows from the three block stations approaching to footing up on the above moisture is disturbed. As the picture shown the water percolates through the foundations. The venue of this block compound there are 6 (six) blocks and Out of six blocks five blocks selected for the purpose of this study. The researcher conducted detail studies like differential settlement, detaching of the wall from the pavement and the building crack marked. In some areas the houses are built in better way, for example if the contractor constructed nicely the other follows his shoes. By the same taken/logic in some occasions there is a presumption/exception collapsing of block 221.there is a possibility a contractor may be given two blocks. The contractor who constructed block 220 may construct other block in this compound. This shows all contractors who deployed on the five blocks are responsible for failures of the blocks with other concerned bodies. In general many of the respondents mentioned that the failures of Block 220 were directly attributed the concerned body. Respondents believe that the damages through use of inferior material, ignorance and negligence.

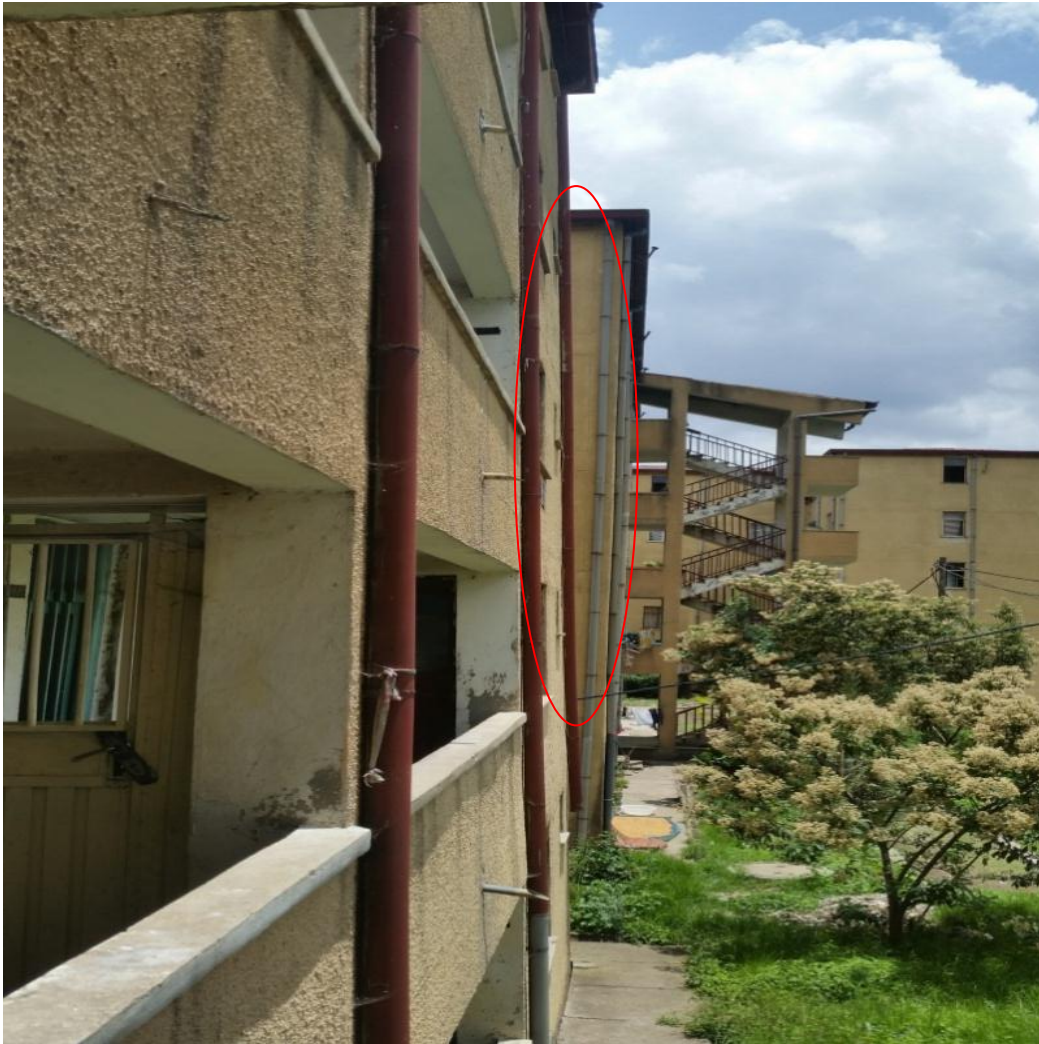
Figure 4.30. The front image of tilted block 220 at Jemo No.1 Condominium Site

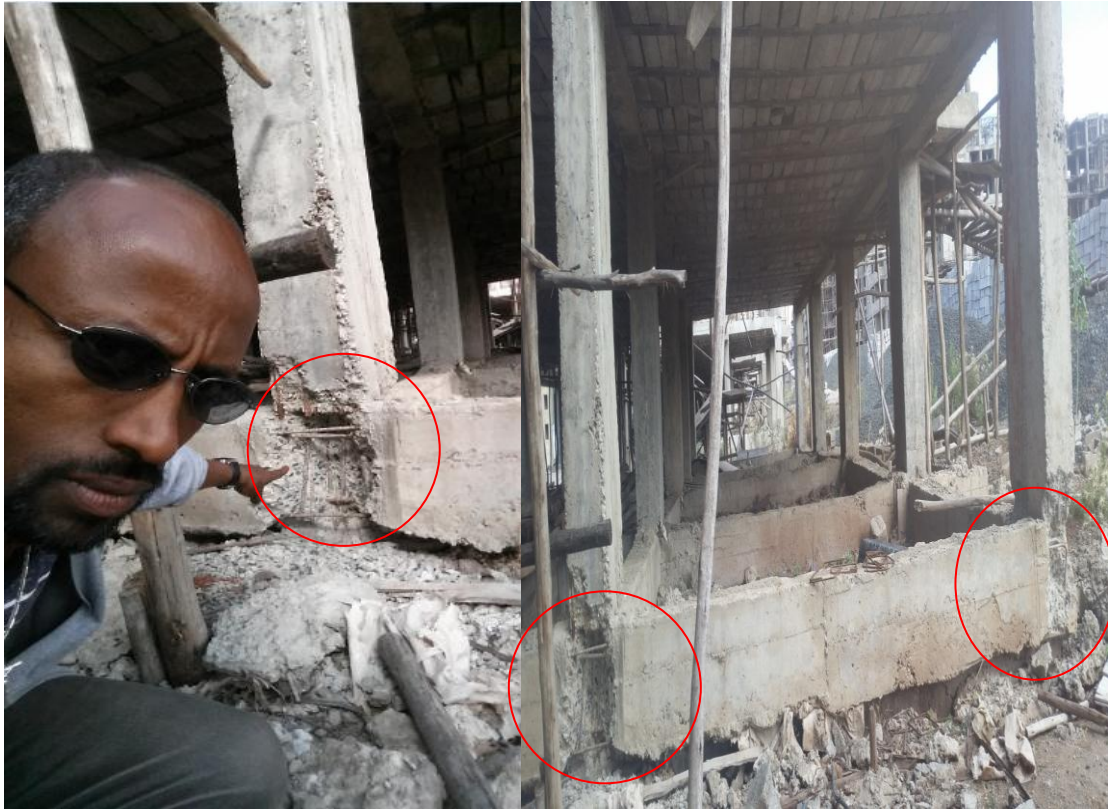
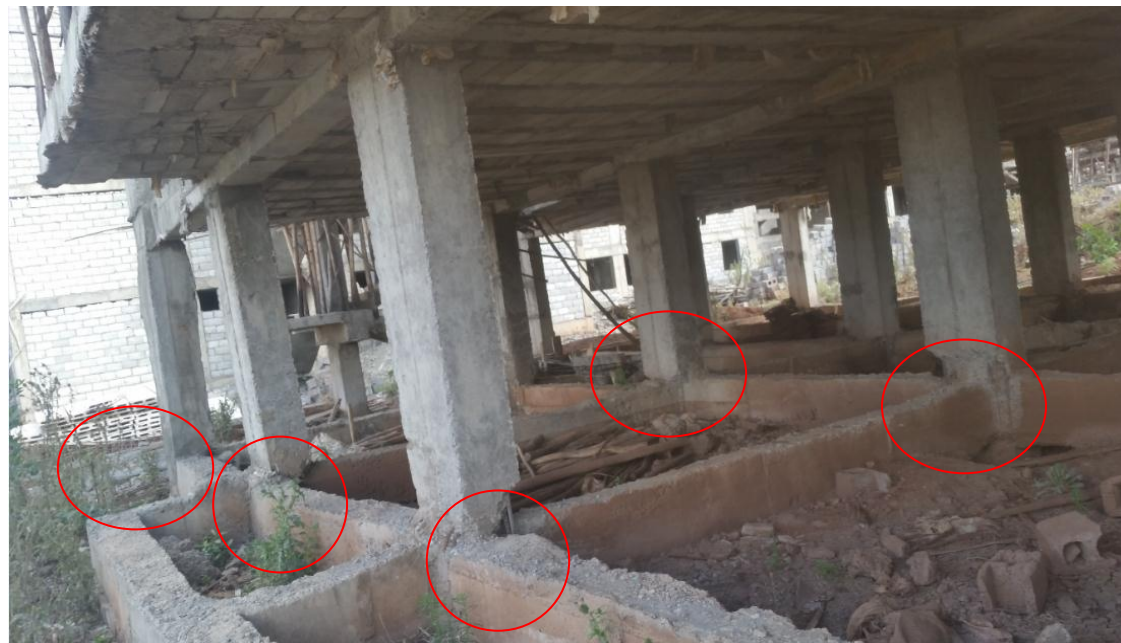
Appendix 1: KoyefечеSite, the abovephotos show the columns are notconnected with the foundation reinforcement and shifting of eccentricity

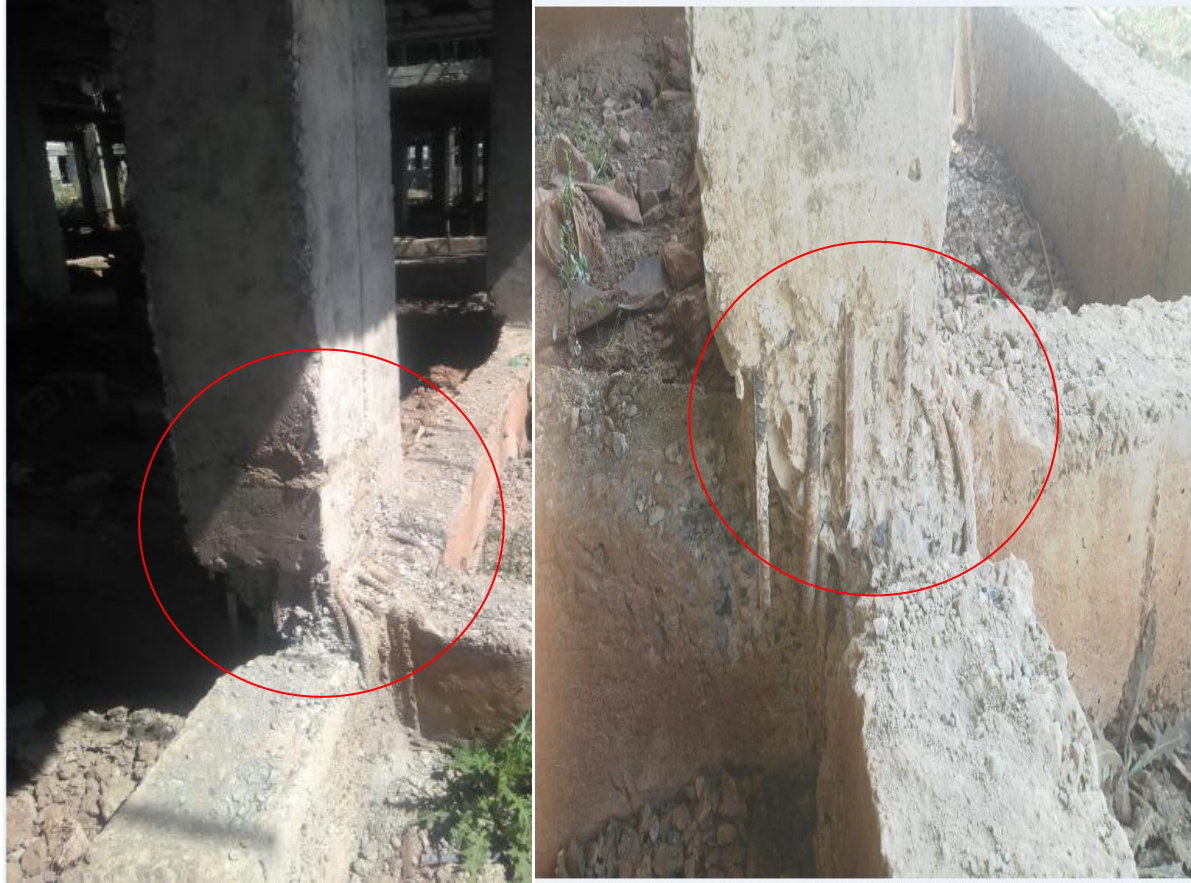
Appendix 2:Koyefeché, these photos show Shifting of eccentricity

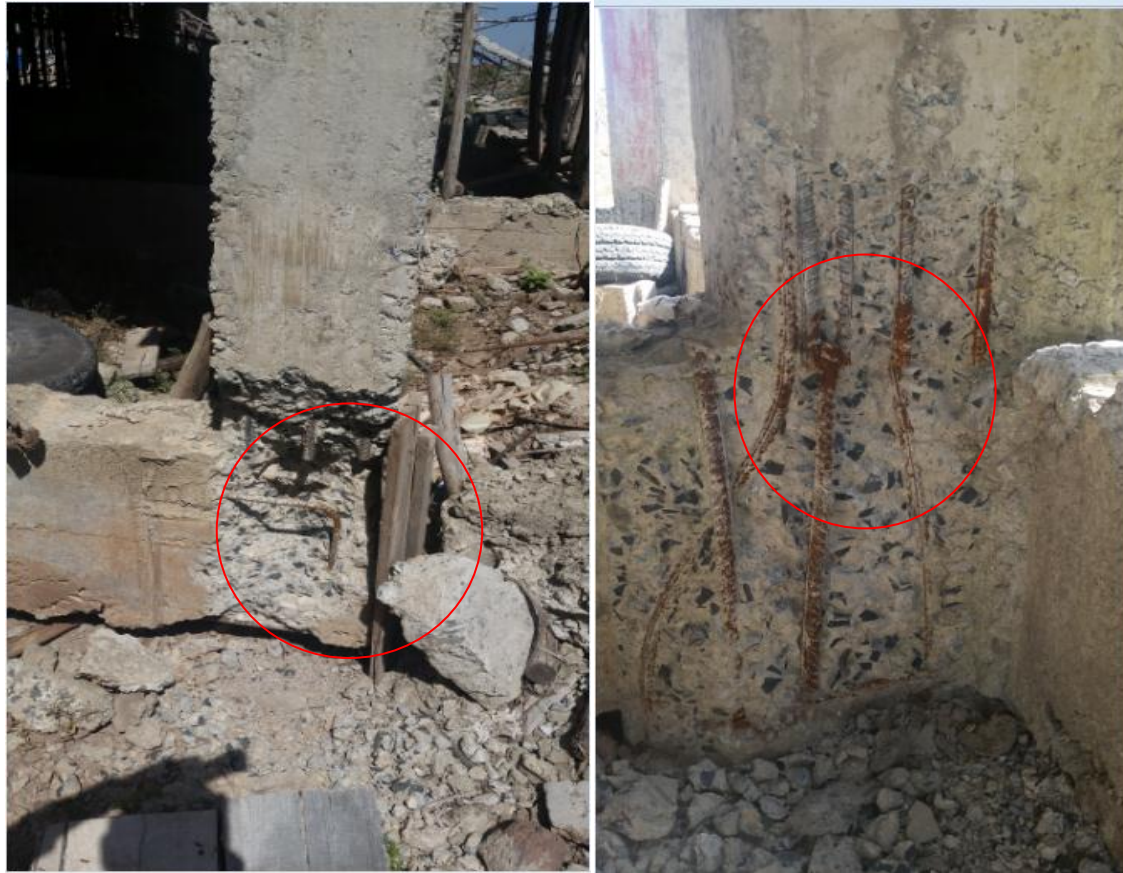
Appendix 3: Koyefече, the left side of the photo shows the column is not connected with the foundation reinforcement and the right side of the photo shows shifting of eccentricity

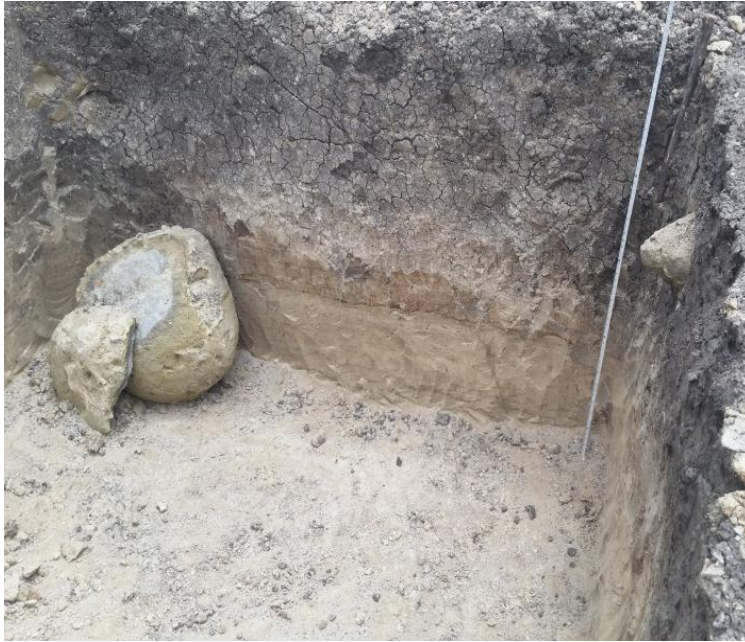
Appendix 4: Bole Arabsa 5, this figure shows after a certain depth the picture seems stone however, a manner touch disintegrate in to small particles.

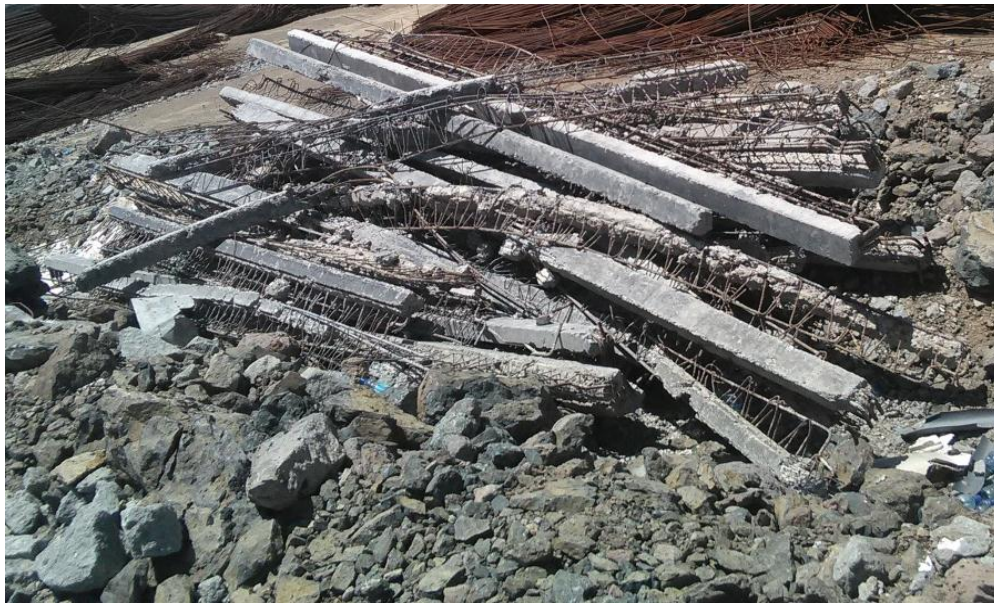
Appendix 5: These precast were broken down on the spot of dropping from the car when I was conducting field observation (Bole Arabsa 3)

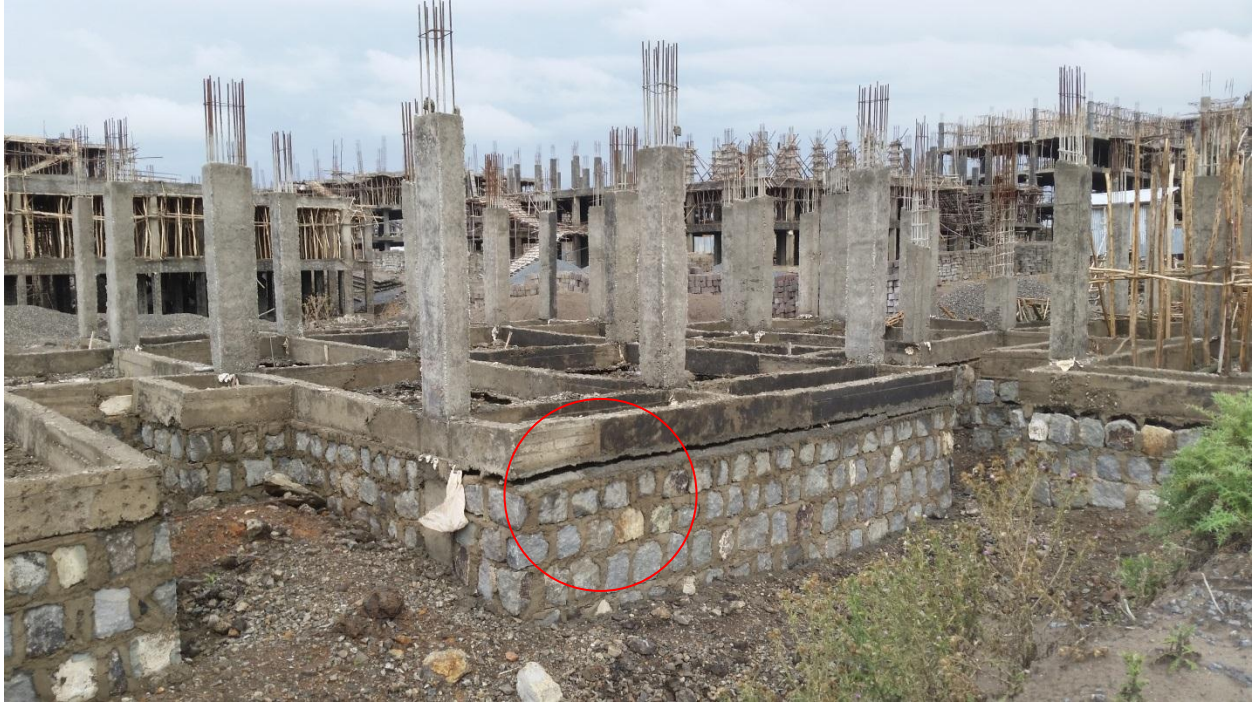
Appendix 6: Differential settlement problem and settlement of masonry wall below the grade beam

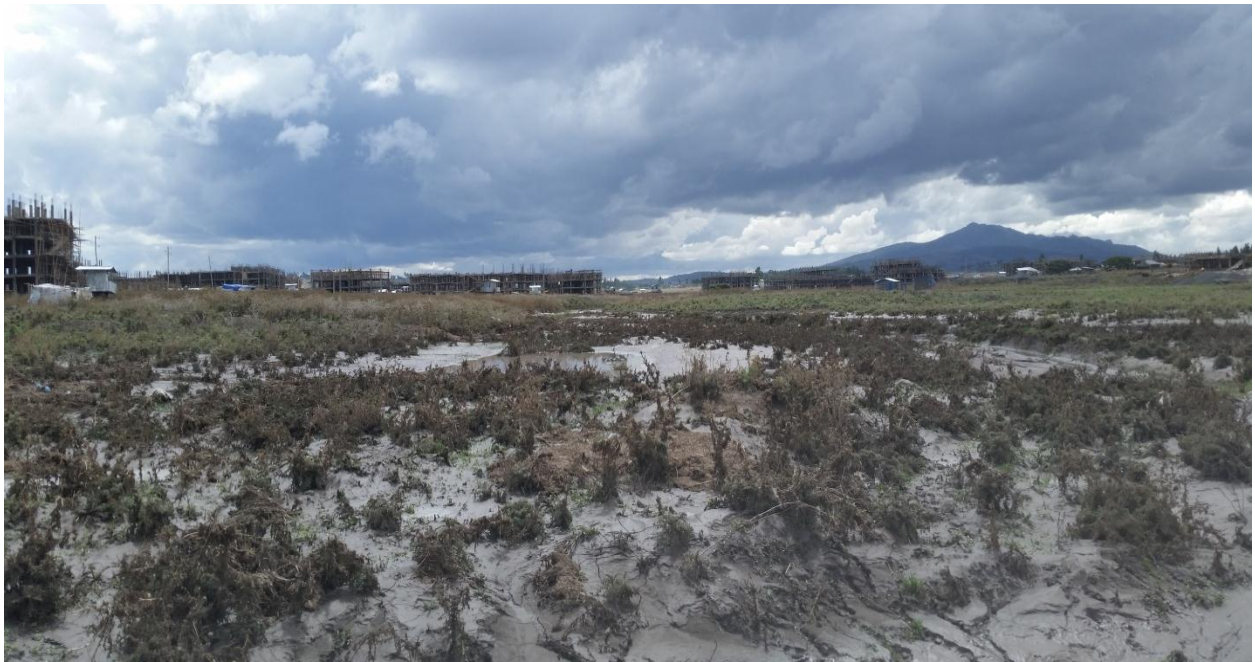
Appendix 7: Currently, the flat areas are highly affected by flooding and emerging up of small streams, thus affecting Koyefече Construction sites

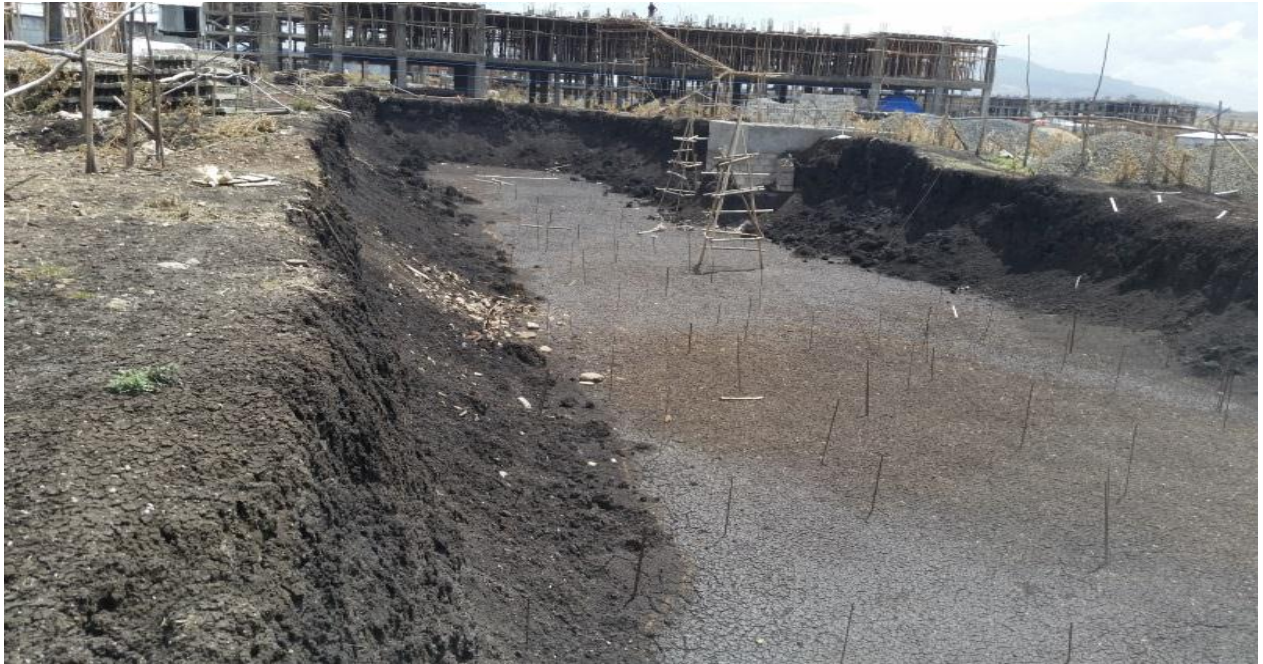
Appendix 8: koyefeché project 12(G+7) and selected for isolated footing

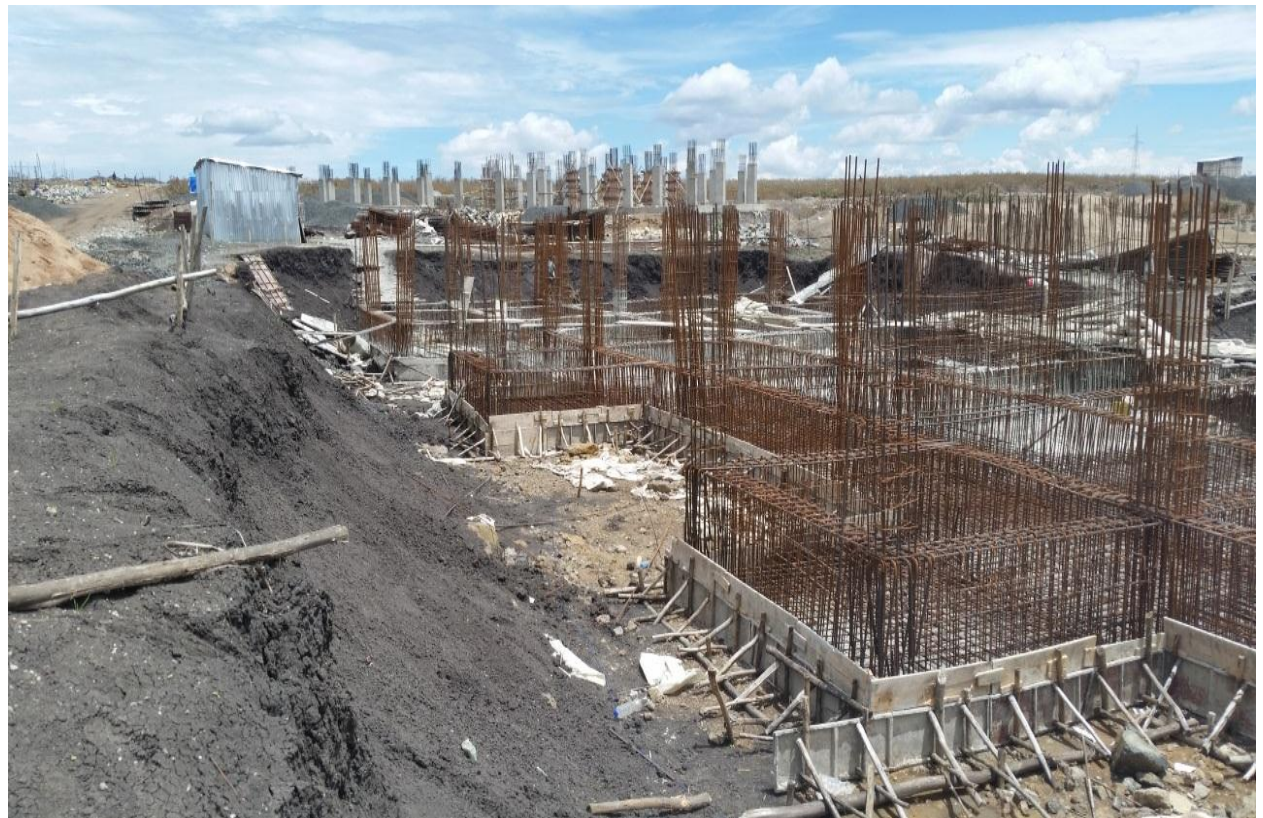
Appendix 9: Bole Arabsa 5 (G+7) and Mat Foundation
